HIGH-SPEED GEAR VIBRATION AND NOISE EXPERIENCE

Norman E. Bruce

Shell Oil Company

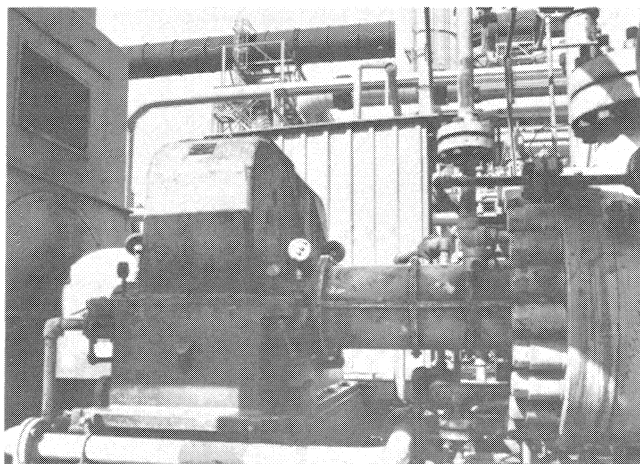
When the motor and gear-box were started together, they ran beautifully for about one minute before pinion precession-shuttling with its very disturbing noise and vibration started.

Figure 2. Gear Box Subject to Precession-Shuttling of Pinion.

Fortunately, the vibration and noise severity increased gradually as the oil warmed which allowed operation for another 30 seconds before shutdown action was required. After shutdown, the gear and pinion teeth were inspected through the hand hole; the bearings were examined by removing labyrinths and shaft end covers for visual access; and the bearing clearance was roughly measured with dial indicators by prying up the shafts. Since there was no apparent damage to the gears or bearings, a second trial run was made to collect diagnostic data. Vibration velocity transducers were attached to the bearing housings and the output of the transducers was tape recorded while the gear-box was started and operated for about 90 seconds, 30 seconds in the precession-shuttling mode. Spectrum analyses of the recorded vibration data showed that the gear-box operated normally through the 15 second start-up and for 45 seconds at full speed before precession-shuttling started. After precession-shuttling started, the vibration of the unloaded end of the pinion (opposite coupling) became very severe. The spectrum analyses showed many strong harmonics of running speed vibration indicating impacts or orbiting of the

pinion in loose fitting bearings. The vibration diagnosis was precession-shuttling caused by the overhanging weight of the coupling or a large unbalance couple.

The excessive pinion bearing clearances of the following two locations, (1) journal to bearing inside diameter and (2) bearing outside diameter to bearing housing inside diameter, were the most significant findings; therefore, controlling bearing clearances became the target for corrective action. A set of bearings was selected with 8 mils clearance and a 1/32-inch deep pressure dam 3 inches wide and 135 degrees long was machined from 3:00 o'clock to 10:30 o'clock in the top bearing half (see Figure 3). When the bearings were installed, the horizontal joint of the bearing insert was shimmed and doweled to make the bore concentric and parallel to the outside diameter, and shims were added between the top of the bearing insert and the inside diameter of the bearing housing to

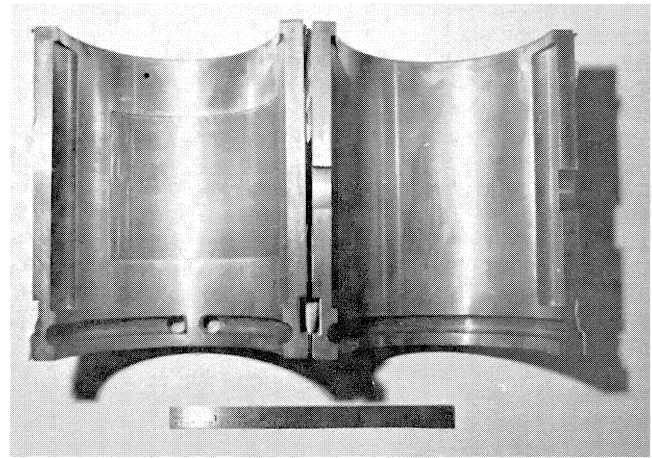
Figure 3. Modified Pinion Bearing Pressure Dam was Cut and Shims were Used at Horizontal Joint.

assure a good fit. The spots were scraped from the inside diameter of the bearings. Some corrective scraping was done to improve tooth contact, and a final tooth contact correction was made by shimming one corner of the gear-box.

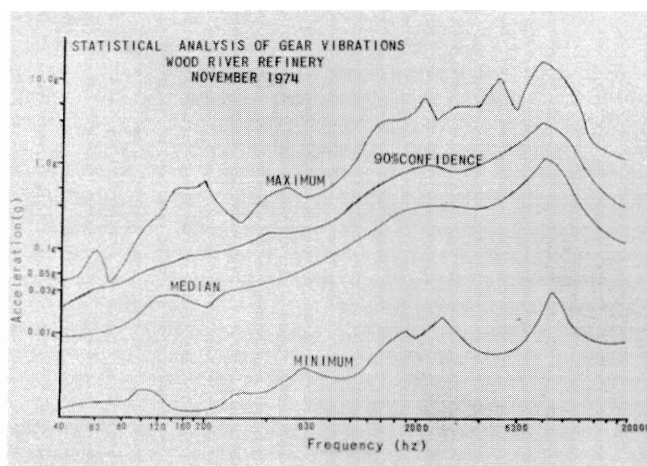
This vibration was high enough to warrant a statistical look at gear vibration (see Figure 4). The statistical spectrum presented was assembled from a five-year accumulation of vibration data in our files for 22 comparable high-speed gears. When the 20g mesh-frequency vibration of this gear was removed from the sample, the next highest vibration was 10g. Ninety percent of the gears had mesh-frequency vibration of 3g or less. The median mesh-frequency vibration was 1.3g.

Examination of the data from several gear failures led to the conclusion that a 10g mesh-frequency vibration was operable; 20g was unpredictable; and 30g to 40g was very close to inoperable. Gears with visible damage to the tooth finish vibrating 30g to 40g would not last more than a few days.

Figure 4. Statistical Vibration of High Speed Gear Boxes. Accelerometer Data Taken from Bearing Housings of 22 Gear Boxes with Mesh Frequencies from 3000 Hz to 10,000 Hz.

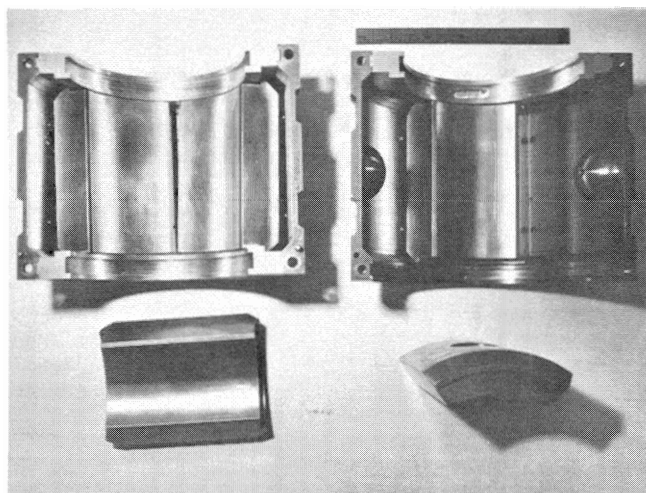
Figure 5. Tilting Shoe Radial Bearings with Six Mil Clearance before Installation on Pinion Shaft.

During the November 1975 maintenance shutdown, the gear-box was sent to the bearing shop where the pinion bearing housings were rebored and fitted with five-pad, tilting-shoe bearings. The pads of thin-babbitted bronze were mounted on hemispherical buttons giving them freedom in two planes (see Figure 5). When the gear-box was reinstalled at the job site, it was found that the 6-mil radial clearances were correct, the

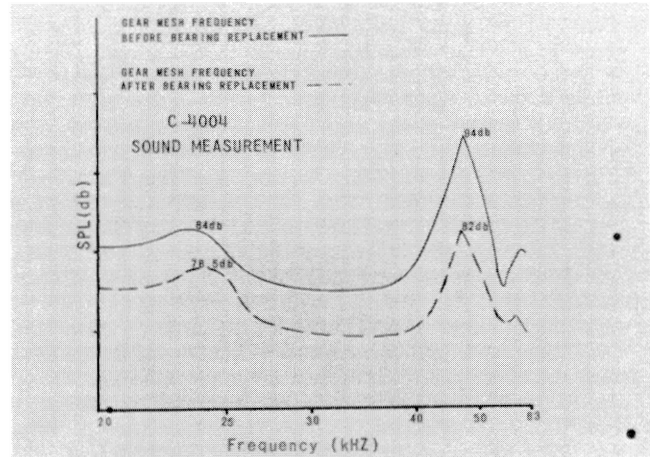
The gear-box, when placed in service, ran beautifully with only a 15°F rise in bearing oil temperature. The mesh-frequency vibrations at 4806 Hz dropped from 26g to 3.1g (see Figure 6). The mesh-frequency noise dropped 12dB from 94dB to 82dB when measured in the near field (see Figure 7). The noise measurement 3 feet to 4 feet from the machine dropped 1dB to 2dB. This small general reduction was caused by the sound power of other contributing noise sources. Near-field measurements were made 2 inches to 3 inches from the gear-box cover just above the horizontal joint. In this noisy environment, near-field measurements were the only way to be sure gear noises were received exclusively.

Figure 7. Noise Spectrum Analyses Showing Reduction of Mesh Frequency Noise in the Near Field from 94 dB to 82 dB.

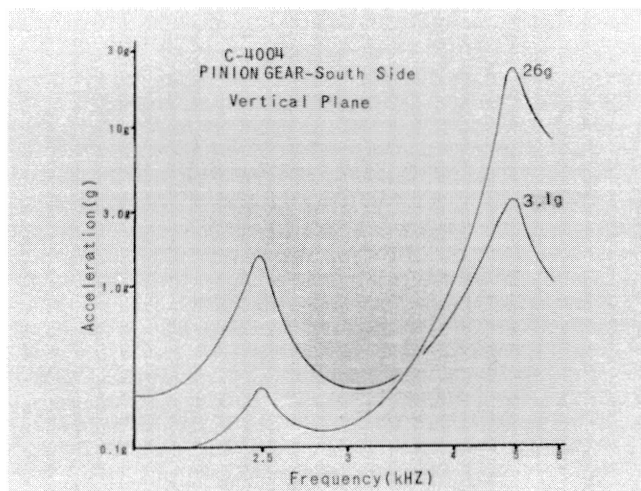
Figure 6. Vibration Spectrum Analyses Showing Reduction of Mesh Frequency Vibration from 26g to 3.1g at 4806 Hz.

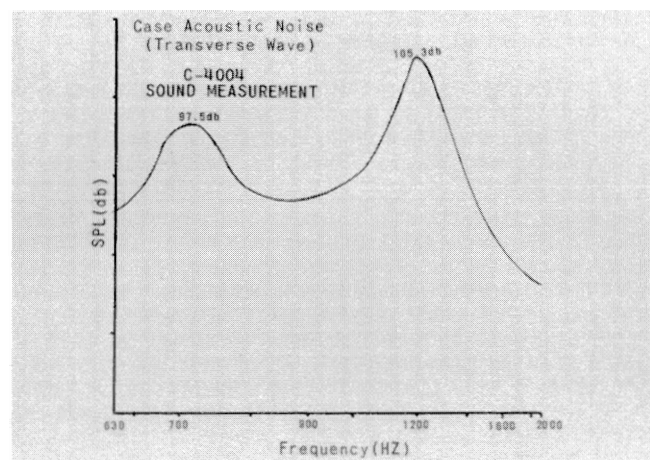
In the course of making sound measurements, a strong noise peak of 105dB was noticed at 1200 Hz (see Figure 8). Very rough wave length calculations indicate that the width of the gear-box in the large space above the pinion is two acoustic wave lengths at 1200 Hz, in air.

We presume the source of excitation was windage from the top half of the gear. The oil suspended in the air makes it impossible to know the true speed of sound in the gear-box; therefore, the plan is to drill and tap a hole in the side of the gear-box cover above the pinion and insert a microphone to get a sound pressure profile across the width of the box. If this experiment proves the existence of a standing wave, an installation of baffles at pressure nodes (velocity antinodes) will be made in the top half of the box over the pinion to break up the standing wave pattern. An alternative would be to install Helmholtz chambers at pressure antinodes to interfere destructively with the standing wave. A howling pump and a howling boiler superheat header have been successfully silenced with these resonant cavities. Helmholtz chambers must be pretuned ex-

Figure 8. Noise Spectrum at 1200 Hz. Inside Width of Rectangular Box Cover above Pinion is Exactly Two Wave Lengths, 22 Inches.
